Manhole Inspection Summary

Manhole # S11II1006MH

Insp Date: **5/25/07 8:44 AM**

Location Address: **2807 RIDGEWOOD RD** Cross Street: **REISTERSTOWN RD**

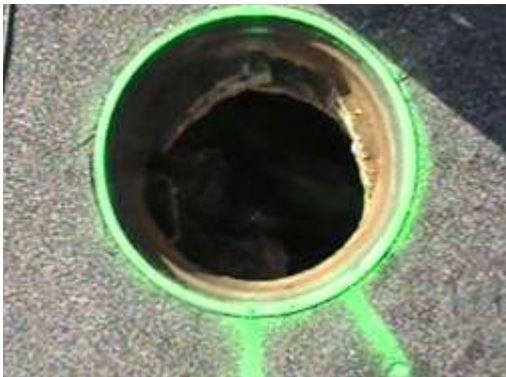
Defect 2

Frame Offset: **4** (in.) Condition: ☒ Sound ☐ Cracked ☐ Leaks

FRAME OFFSET

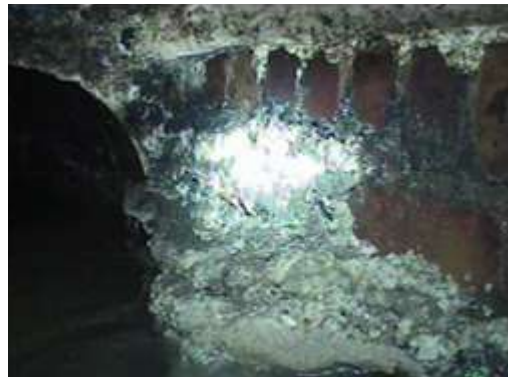
Defect 1

Condition: ☐ Sound ☐ Cracked ☐ Root Intrusion ☐ Deteriorated ☐ Leaks ☒ **Debris**

GREASAE IN CHANNEL

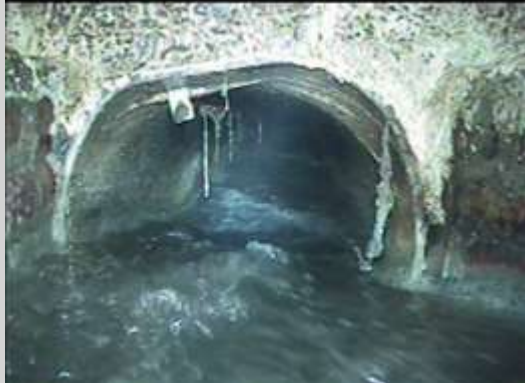
12 O'Clock Outflow

15 in. Circular Gravity Sewer
Pipe Out @ 12 O'Clock

Pipe Height: **15.6** (in.) Rod and Bar (Angled)
Pipe Material: **PVC** ☐ Pipe Lined
Invert Depth: **15.56** (ft.) Flow Characteristics: **Fast**
Deposits: ☒ None ☐ Mud ☐ Sludge ☐ Debris ☐ Grease
Silt Depth: (in.) Deposits Extent:
Infiltration: **None** Pipe Seal Cond: **Sound**

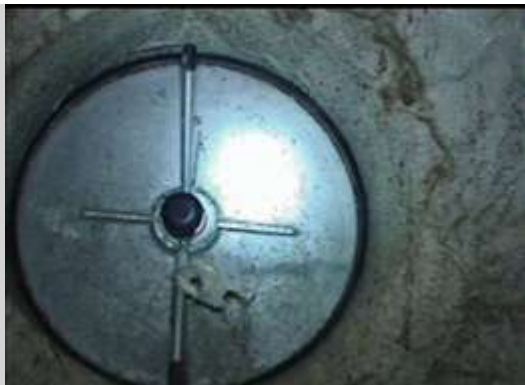
12 O'Clock Outflow

15 in. Circular Gravity Sewer
Pipe Out @ 12 O'Clock

Pipe Height: **16.8** (in.) Rod and Bar (Angled)
Pipe Material: **Unknown** ☐ Pipe Lined
Invert Depth: **10.10** (ft.) Flow Characteristics: **None**
Deposits: ☒ None ☐ Mud ☐ Sludge ☐ Debris ☐ Grease
Silt Depth: (in.) Deposits Extent:
Infiltration: **None** Pipe Seal Cond: **Unknown**

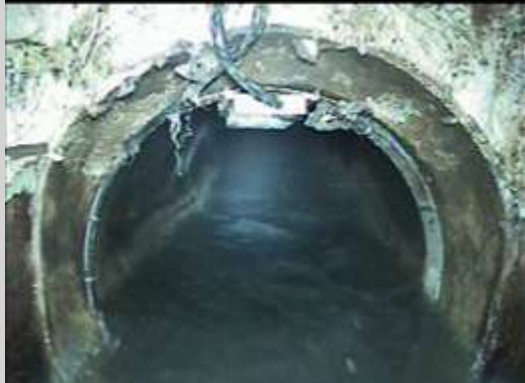
5 O'Clock Inflow

21 in. Circular Gravity Sewer

Pipe In @ 5 O'Clock

Infiltration: **None** Pipe Seal Cond: **Sound**

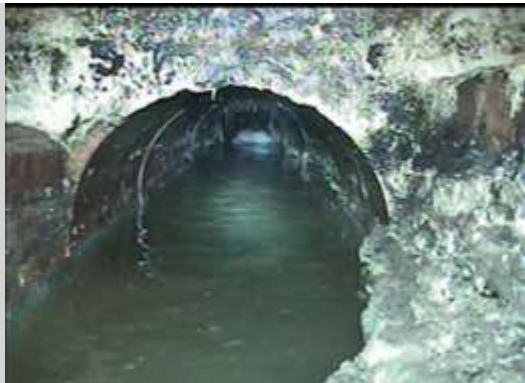
6 O'Clock Inflow

15 in. Circular Gravity Sewer

Pipe In @ 6 O'Clock

Infiltration: **None** Pipe Seal Cond: **Sound**
